HEGOA 800 is a system for air purification and deodorisation by 3 active technology filtration + ultraviolet + photocatalysis.

TECHNICAL DATA

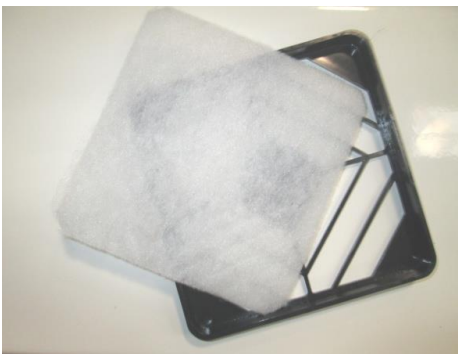
G2 Filter

- Replace the **G2 filter** (if dirty)
- Change the **TiO₂/activated carbon filter and G2 filter** once a year.
- Replace the UV lamp after 9000 hours of operation

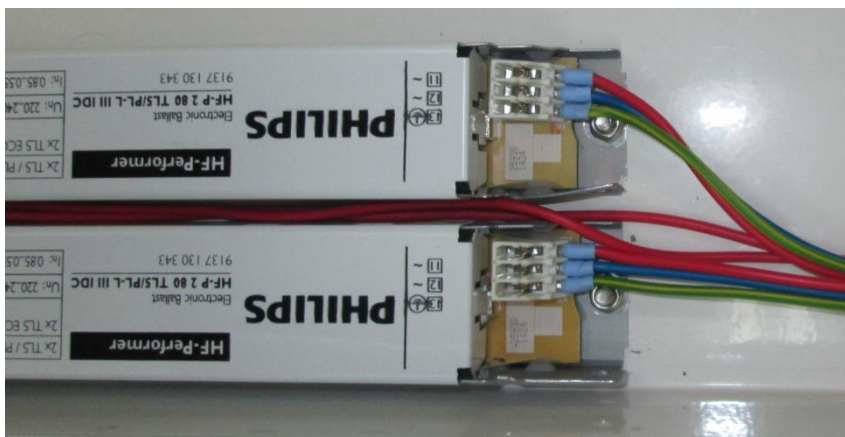
2) BALLASTS POWER SUPPLY :

Ballast wiring :

Phase : Red
 Neutral : Blue
 Ground connection :
 Green/Yellow
